**IN THE HIGH COURT OF NEW ZEALAND  
AUCKLAND REGISTRY**

**CIV-2014-404-000716  
[2024] NZHC 32**

IN THE MATTER OF      The GORE STREET APARTMENTS also  
   known as “HARBOUR OAKS”

**JUDGMENT OF WALKER J**

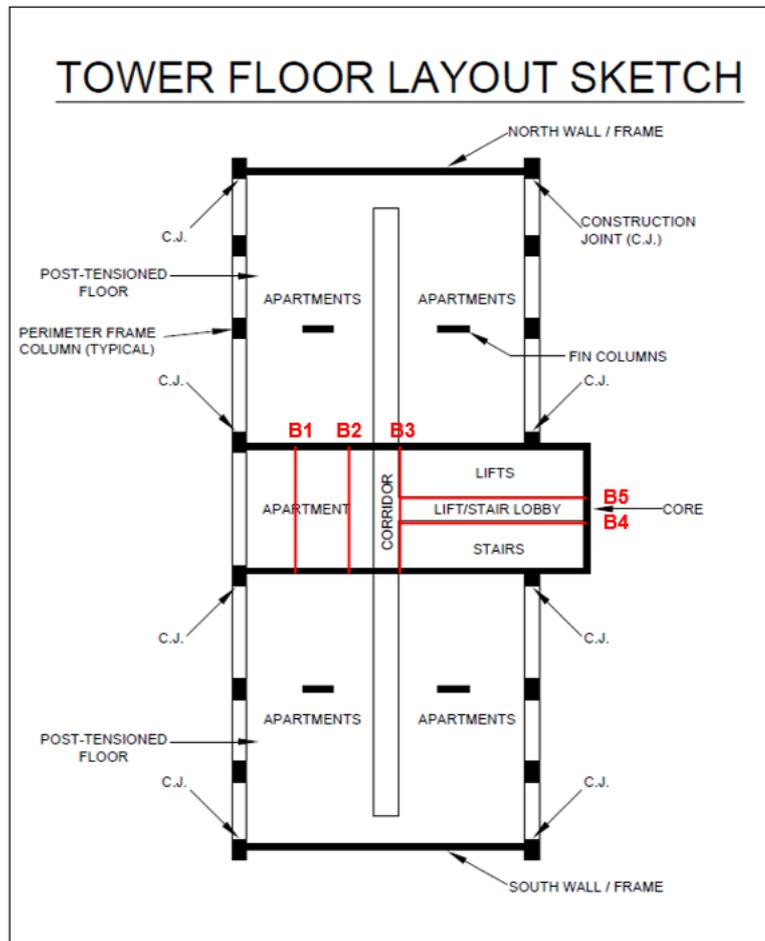
[223] The load-bearing steel-framed elements are steel beams in the Core of Gore Street. The diagram below identifies the position of the main load-carrying beams B1 to B5.

[224] Beams B1 and B2 are within the apartment in the Core on each level. Beams B3 to B5 are in the corridor and lift lobby directly under the walls. Beams B3 to B5 are part of and support the fire separation wall system. Beam B2 also supports the fire separation wall system. Beams B2 and B3 are connected by beam B13 (not shown) all of which support the slab above. Beam B4 is positioned above the stairwell-to-lobby fire separation wall and beam B5 is positioned above the lift-to-lobby wall.

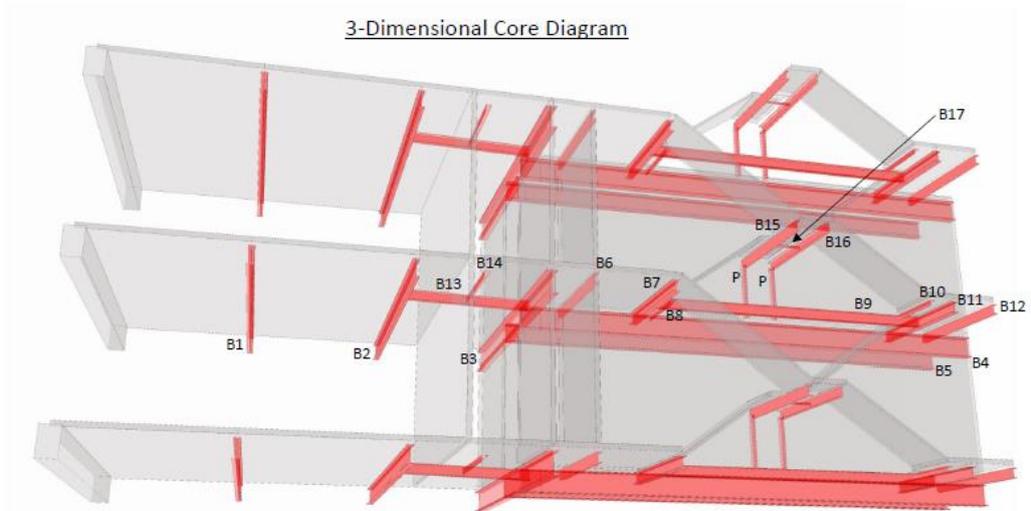
[225] For the sake of completeness below is a three-dimensional diagram showing the floor and a portion of the fire separation wall construction in the Core with the further beams not shown in the tower sketch above.

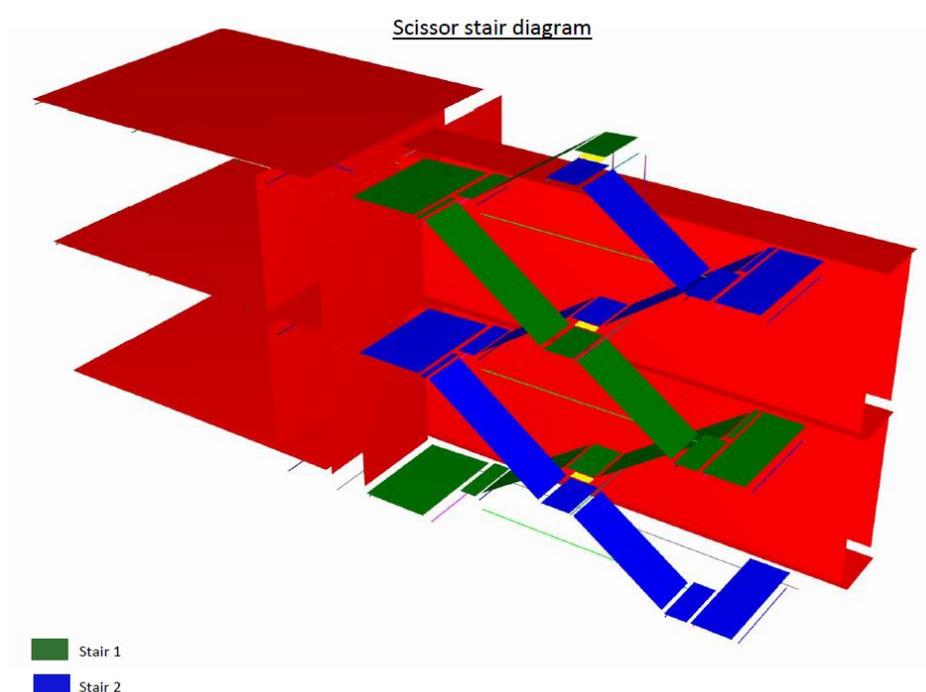
[568] The diagram below depicts the scissor stairs:

[569] I understand that it was common practice at the time of the design of Gore Street to separate scissor-style staircases from each other and from the dividing fire separation wall between them with an ability for the staircase to slide at the foot of each staircase. In this way:

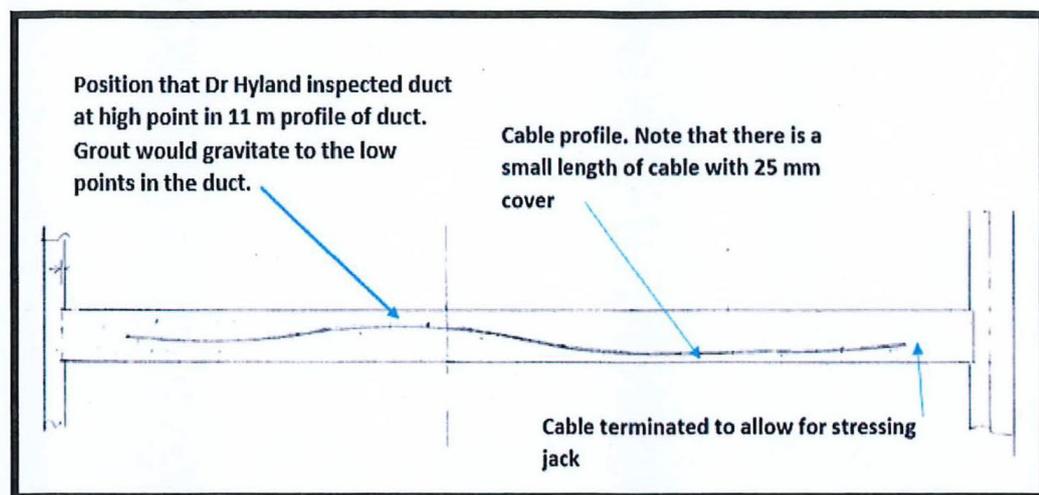
Figure 10: diagram showing typical tendon profile through the concrete slab

[647] The tendon ducts follow a parabolic profile between high and low points as depicted in this diagram:

[648] The plaintiffs spent relatively little time on this issue in closing submissions. They concede that the “issue” is not as severe as the bar sleeves. This is perhaps not surprising given that their own investigations indicate that 80 per cent of the ducts surveyed were adequately grouted.<sup>221</sup> I further apprehend that the remedial fix proposed does not include regrouting but mitigating the issue on a practical basis by adding fire protection to the underside of the slab. In principle though, the lack of grouting in the tendon ducts is of no moment if the plaintiffs have not established that grouting of all (or any) of the tendon ducts is required to achieve compliance. Whether code compliance (or consent compliance) requires grouting of tendon ducts is therefore a live issue. The plaintiffs submit that a failure rate of 20 per cent is unacceptable and suggest that the tendon ducts should all have been full of grout. In my assessment, there is no cogent explanation in the evidence supporting this submission.

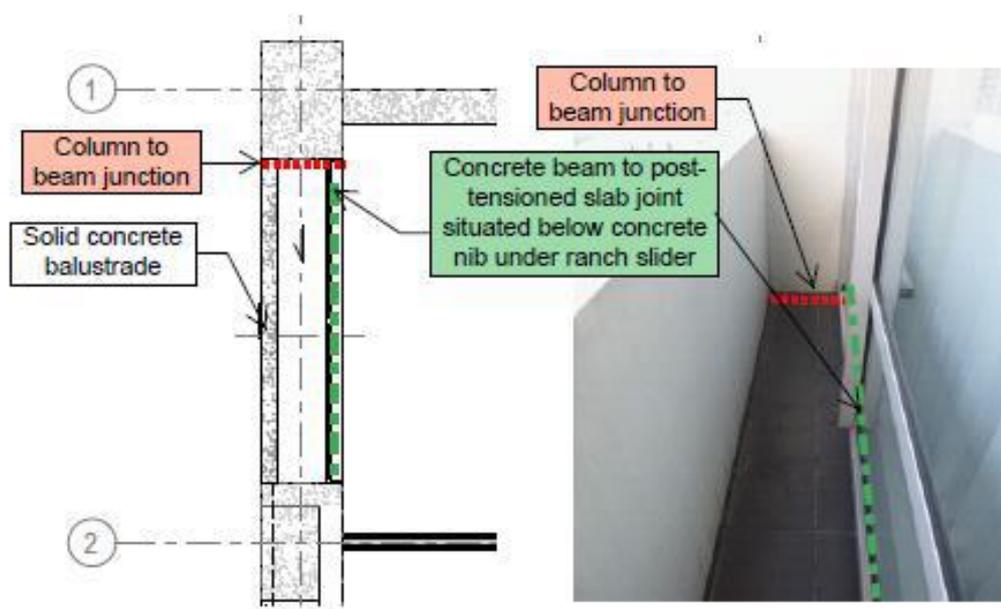
[773] There are two sub-types of narrow balcony — those with solid concrete balustrades and those with metal balustrades.<sup>259</sup> There are 271 narrow balconies with metal balustrades and 221 narrow balconies with solid concrete balustrades. This following diagram depicts the general structure of a narrow balcony with concrete balustrade:

[774] Not all of the narrow balconies have both junctions featured in the photograph.<sup>260</sup> There are 290 narrow balconies with column to beam junctions or joints (shown as the red dotted line). There are 142 narrow balconies which are not over beam to column junctions but have the post tension beam joints below concrete

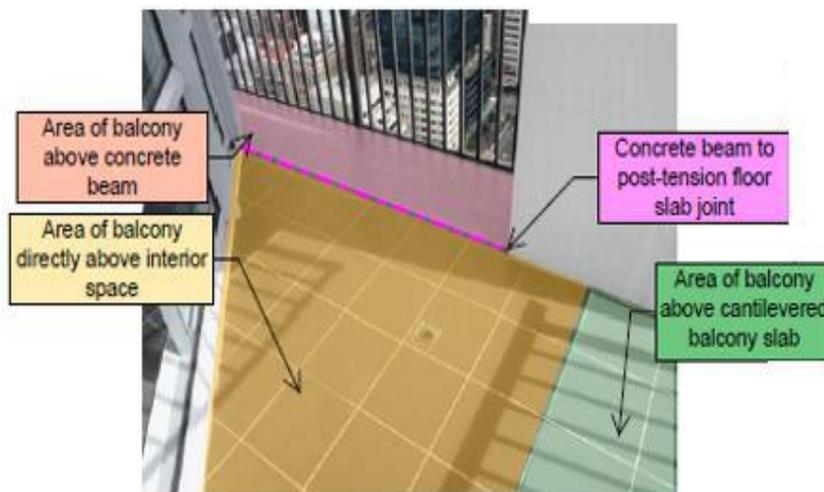
**Fig.2 - Photograph of Typical Corner Balcony**

[777] The photograph below illustrates a typical corner balcony and the construction joints or junctions. All the coloured areas are part of the balcony. Two relevant features of this balcony type are the beam to post-tensioned floor junction (shown by the pink dotted line) and a beam to column joint (hidden in the photograph; it is where the base of the white column meets the pink section). The cantilevered slab to column joint is at the base of the arrow where the green section meets the column.

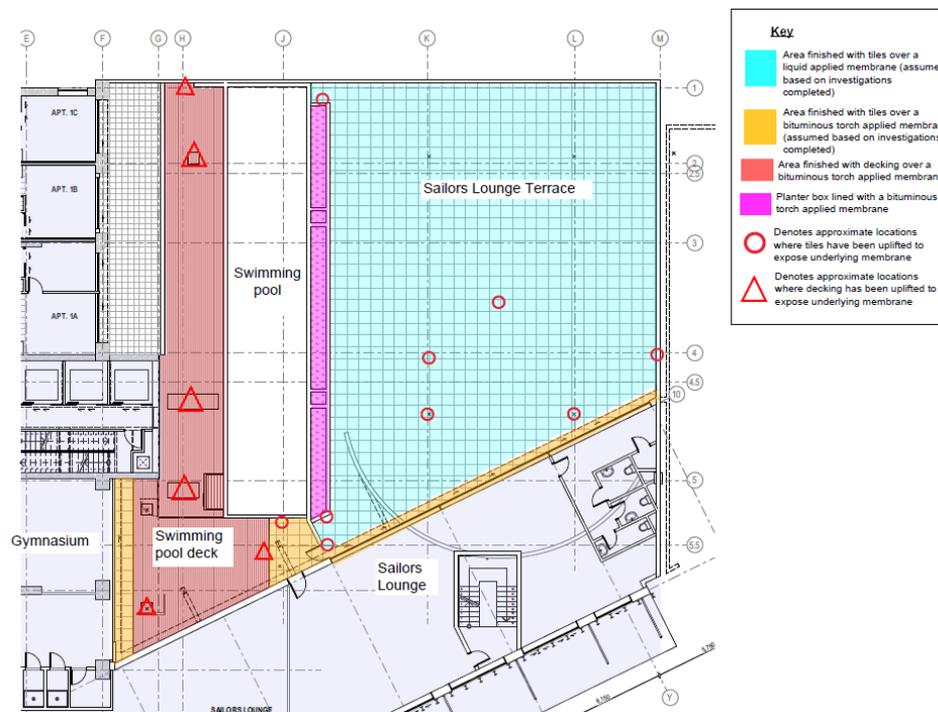
[956] The podium areas are shown below:

[957] There is a double layer torch-on membrane (Tremco Tremproof 3000) installed below timber decking in the swimming pool deck area, in a narrow strip on the south side of the terrace outside the Sailor's Lounge entry and adjacent to the pool gate and in front of the gymnasium. This is shown in red and yellow on the diagram. The

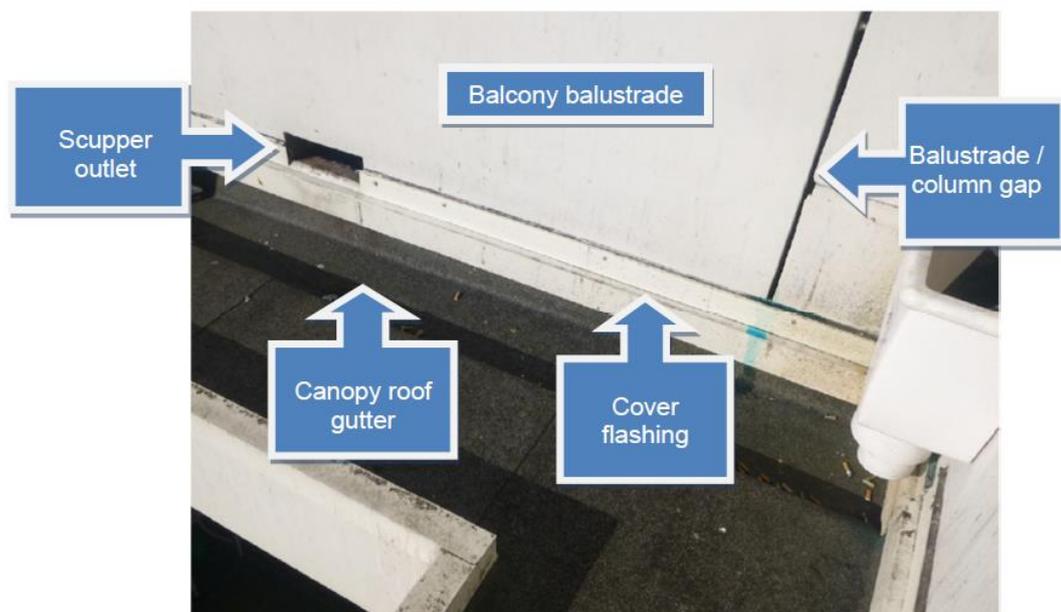
[1104] Critically, there are junctions between the canopy roof and the balconies at the base of the tower. The membrane is installed with an upstand — turnup onto the vertical face of the balustrade — along this junction. There is a cover flashing on the roof side of the junction extending above the height of the membrane upstand. There are seven scuppers and 14 gaps between the balustrade and columns on the level 3 decks through which water can flow from the decks to the gutter on the membrane roof. An example is illustrated in the photograph below:

[1105] The plaintiffs say that water from the balconies is able to access the top edge of the membrane upstand at the scupper outlets and the balustrade to column gaps. It then tracks behind the membrane into the structure below resulting in timber decay.
