**IN THE HIGH COURT OF NEW ZEALAND  
AUCKLAND REGISTRY**

**CIV-2014-404-000716  
[2024] NZHC 32**

IN THE MATTER OF      The GORE STREET APARTMENTS also  
   known as “HARBOUR OAKS”

**JUDGMENT OF WALKER J**

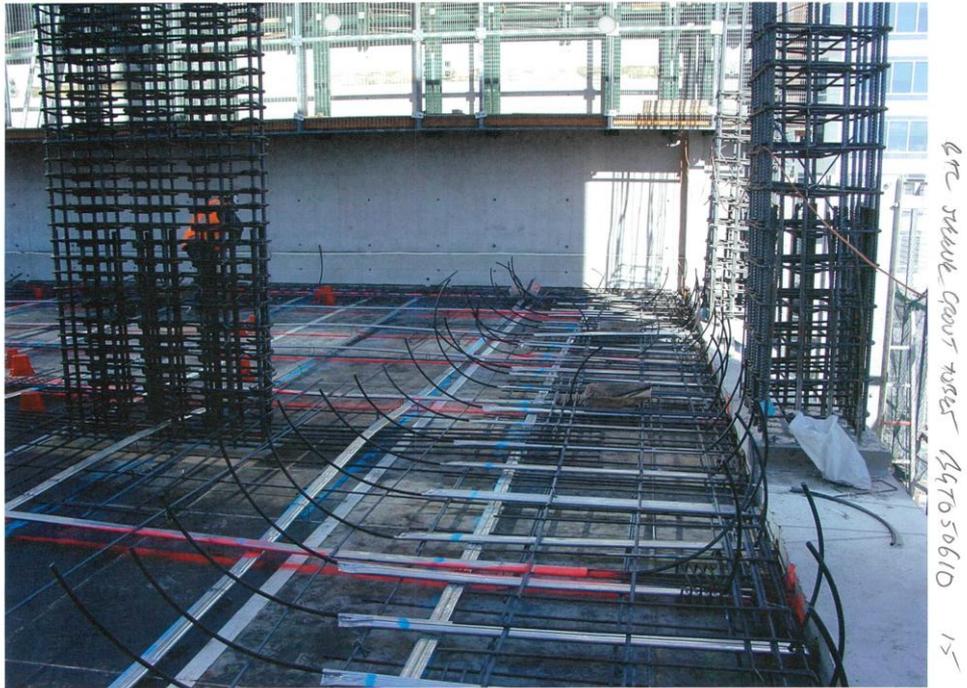
[583] Dr Hyland explained that the bond created enables the slab and the supporting beams and walls to act together as a monolithic system.

[584] The plaintiffs' experts took concrete core samples. They say the sampling showed that 63 per cent of the surveyed bar sleeves were not adequately grouted. No grout was detected in the bar sleeves on level 22. Twenty per cent of the tendon ducts surveyed were not adequately grouted.
